FIDO Sediment Monitoring Sites

To establish monitoring sites to assess the volume and impacts of sediment movement resulting from road usage on Fraser Island

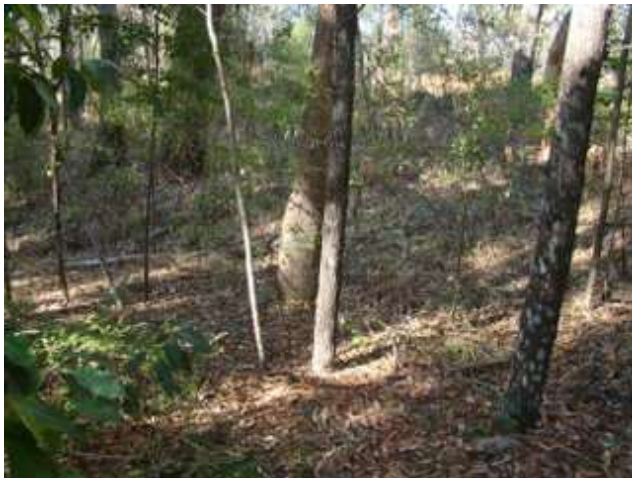
Photo monitoring sighting 27 November 2012

Location Description: A little over kilometre west of Eurong, the two-way road has resulted in a deep down-cutting. Although there is only a relatively small catchment there is evidence of a large volume of sediment accumulated at the site of the datum post. 60 cms down the hole was still in sediment.

- West: The marker is a stump
- South-East: The mark is on a brush box . On 25 November a mark was painted 60 cms above the ground level
- North east: The mark 60 cms above the ground level for photos to be focussed on is in the centre of a scar observed.

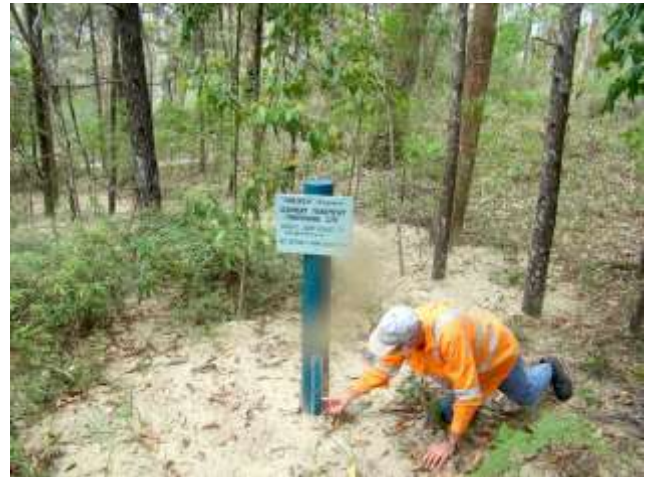
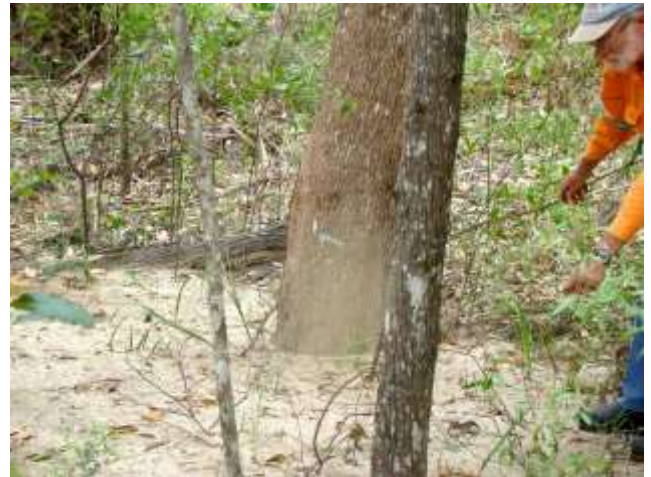
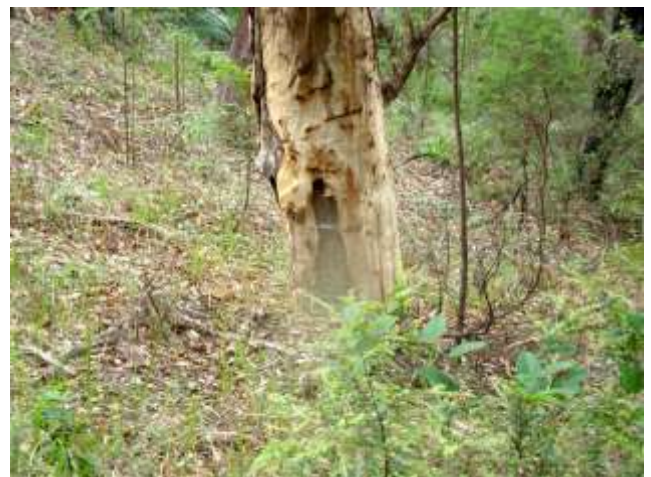
Photo monitoring sighting Cooloola 11-3-2013

90 mm of sediment had accumulated around the datum pole in the first three months after it was installed.

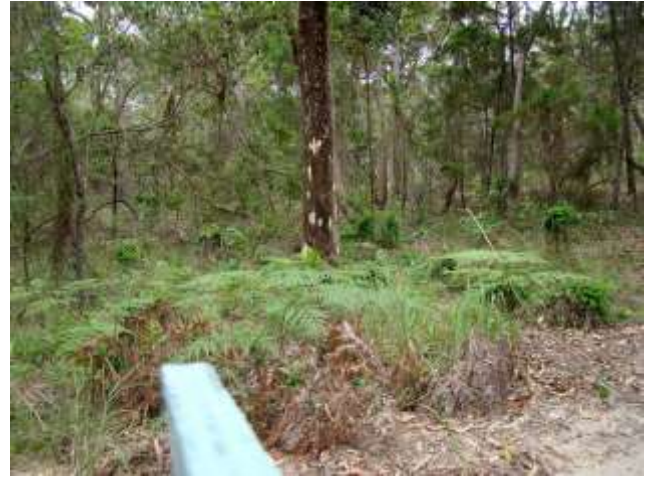
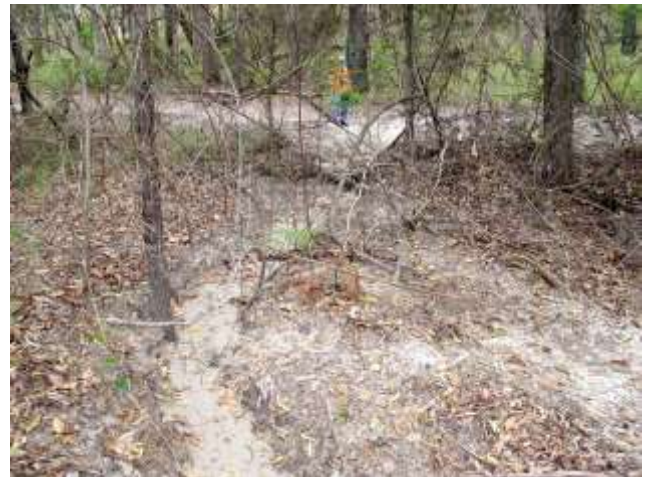
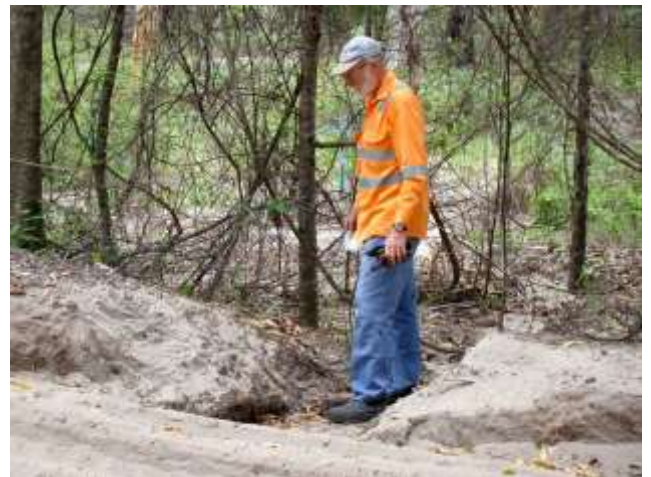
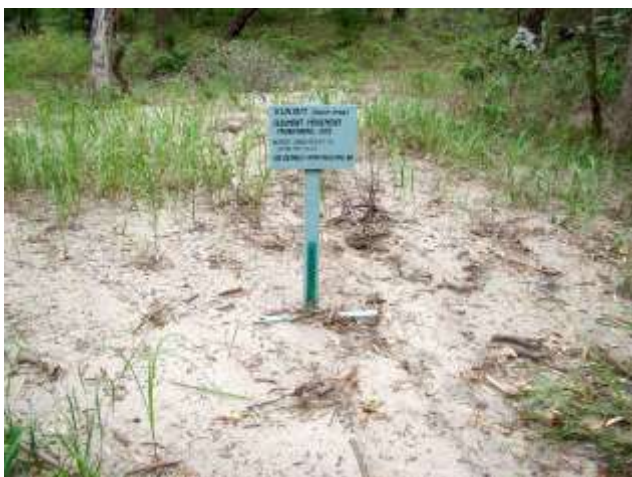
Kunyam monitoring site 11 March 2013

Following the downpours from 25 January to early March much sediment was moved. 40 mm was recorded on the post that might have been more had not an erosion gully developed adjacent to the post.

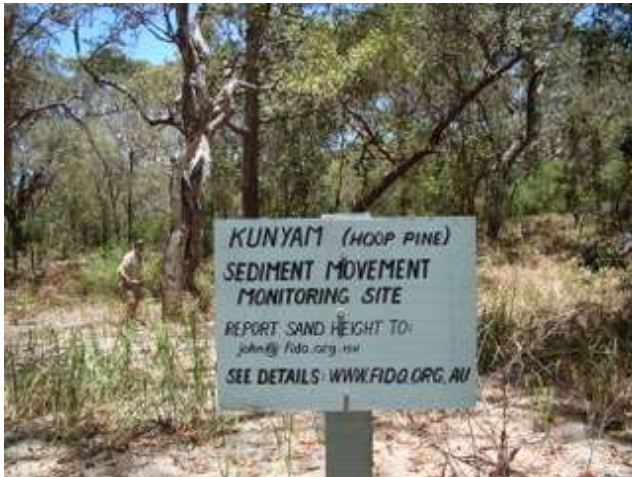
Photo monitoring sighting 27 November 2012

Photo ID Markers: Two trees have been marked to get comparative photos over a period of time from the top of the post.

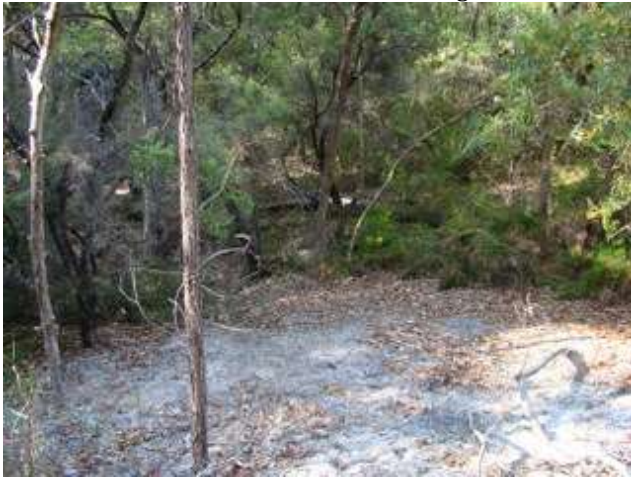
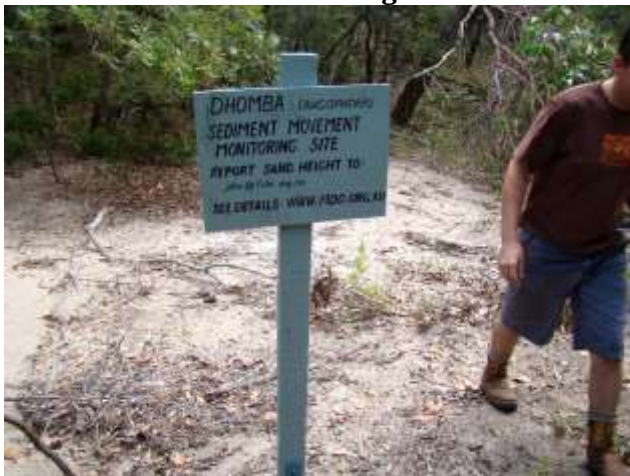
Dhomba Monitoring 13-3-13

Location Description: About 2.5 km west of Eurong, the between the junction of the two one way roads and the Eastern Break. The datum has been placed in the centre of a large alluvial plume. There is a significant catchment extending about 400 metres along the road running towards the point where sediment is moved from the road there is evidence of a large volume of sediment accumulated at the site of the datum post. The hole down to 60 cms was still only in sediment.

Dhomba accumulated 50 mm of sand in the period the monitoring station was passed on Monday 17 February in the midst of a deluge that was captured on camera.

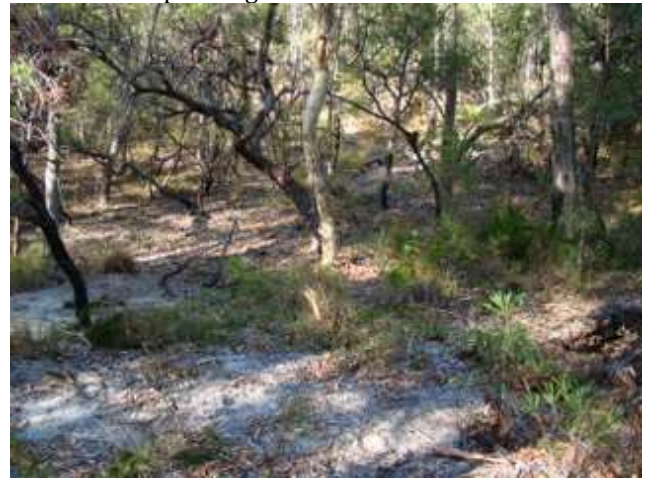
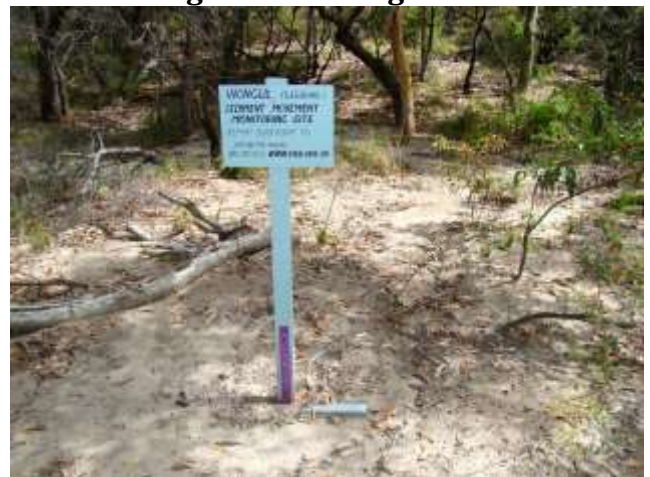
Wongul Monitoring 13-3-13

Location Description: About 200 metres west of the Dhomba monitoring site. The catchment extends for about 200 metres of road running towards the point where sediment is moved from the road there is evidence of a large alluvial plume accumulated at the site of the datum post.

The accumulation of sediment in the 15 weeks has been 50 mm. The area of spread was at least 15 metres by 15 metres that suggests that over 17 tonnes of sand was deposited over this area in this short period adding to the depositions from previous periods of heavy rain in recent years.

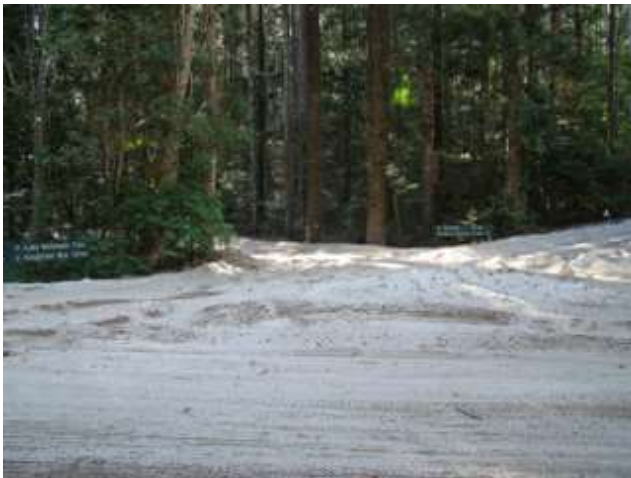
Pibin 28/11/12

Location Description: The site chosen is the crossroads of the Eurong Lake McKenzie (Boorangoora) Road and the Central Station Eurong Road. A vast quantity of sediment has accumulated in the vicinity as evidenced by the road signs being slowly engulfed by road sediment. However the photo monitoring is to focus on three trees that are now subject to change in the short term.

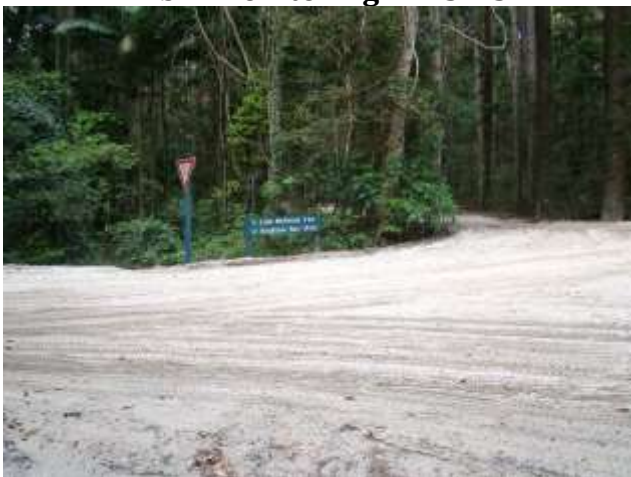
Pibin Monitoring 11-3-13

The accumulation of sediment surrounding Pibin monitoring pole was 20 mm. However the pole is on the edge of a very large area building up from sediment.

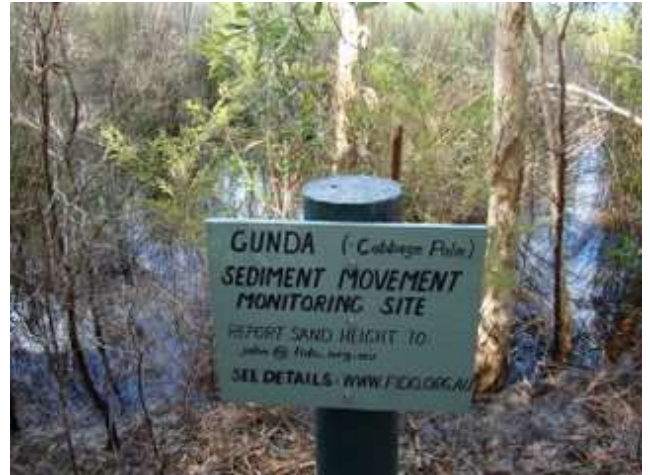
Gunda 28/11/12

Location Description: On the water's edge of Lake McKenzie (Boorangoora) immediately below the site where the road comes closest to Lake McKenzie and creates a large alluvial plume. When sited in November 2012 the lake was still high and only about 30 cms were above water level. It is expected that lake levels will fall and the lake edge retreat the datum post.

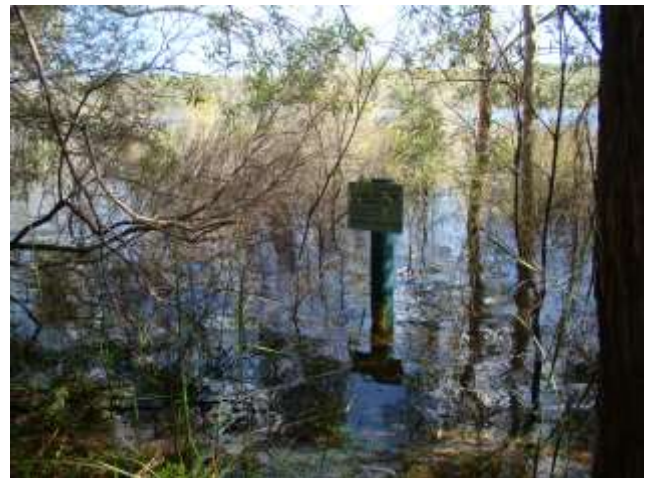
Gunda 15/3/13

The water level had risen about a metre completely submerging the ruler to measure the sediment but although it was impossible to get a reading it was clear that there had been a surprising volume of sediment accumulated because the 50 mm wide cross-bar at the base wasn't visible. Yet the slope down to this point showed no obvious evidence of erosion.

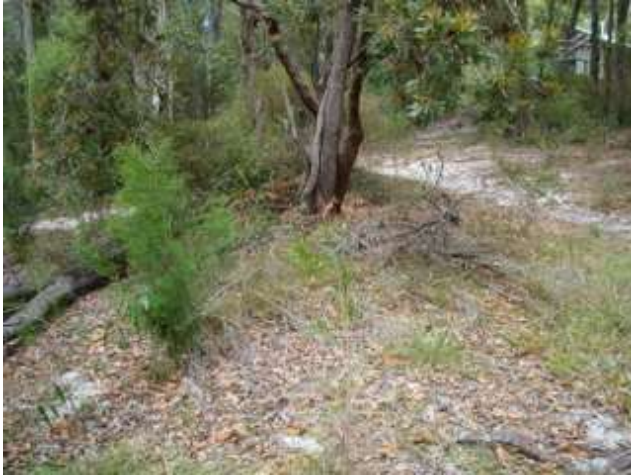
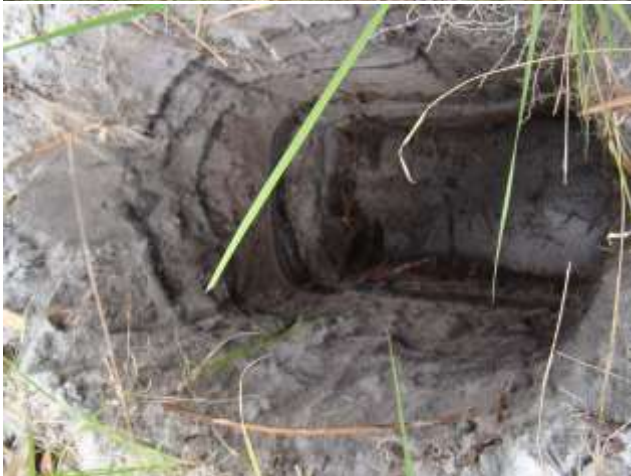
Location Description: this site is in the swale behind the Lake McKenzie (Boorangoora) lunette where sediment is running past the car-park and the easternmost toilet block and there is already evidence of about 2 metres build-up of sediment to be almost a level with the top of the lunette.

Billai 28/11/12 showing episodes of sediment deposits

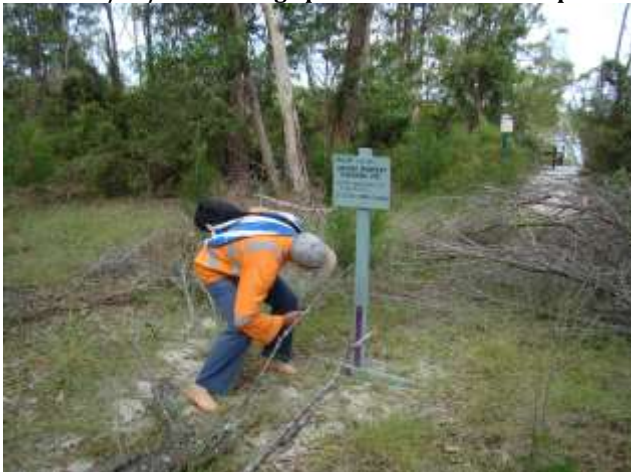
Billai 15/3/13

Less than 20 mm of sediment had accumulated at the base of this monitoring station.

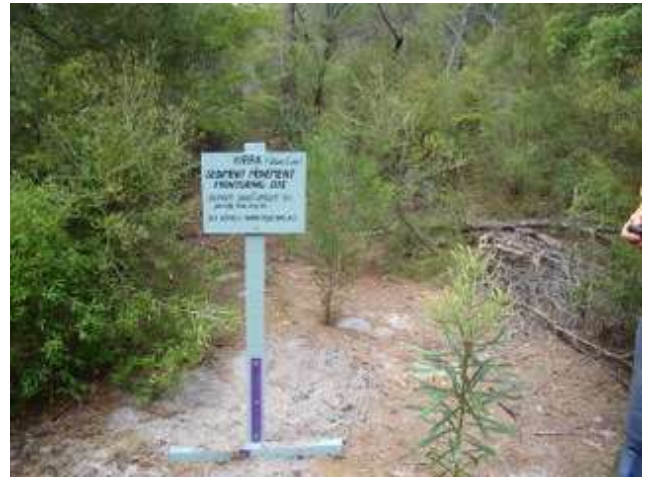
Yirra 28/11/12

Location Description: this is also placed in the swale behind the Lake McKenzie (Boorangoora) lunette and just to the west of the track to the main stairs on to the main beach. Here the deposition of sediment is demonstrably more than two metres in depth.

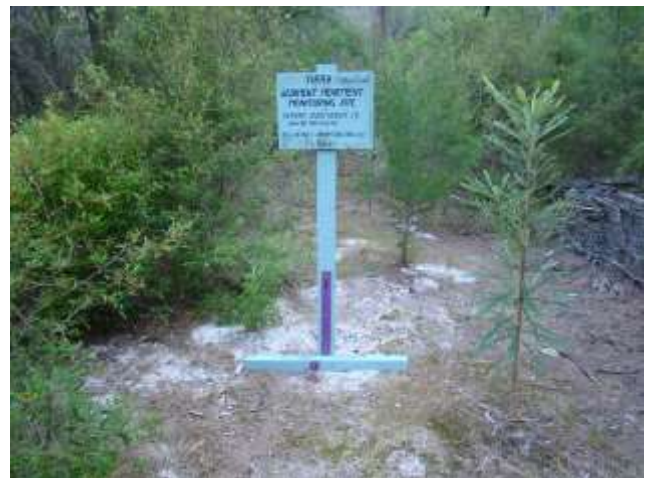
Yirra 15/3/13

This was the only monitoring station where there has been no flow of sediments since the poles were installed.

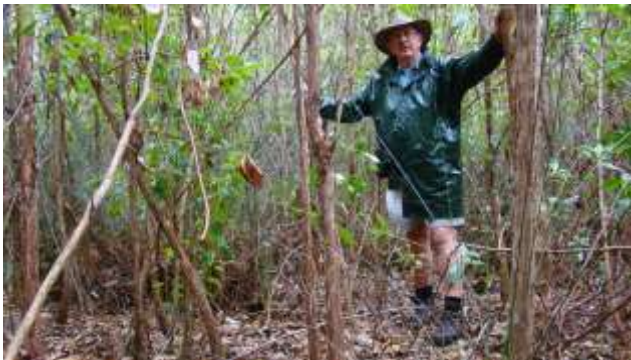
In late November 2010 while preparing an environmental assessment on Fraser Island the growth of a significant forest in the bed of the lake was confirmed

This forest is now growing in what was Yidney Lake

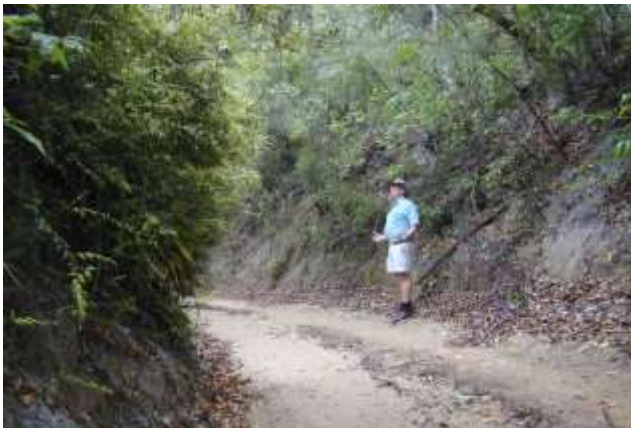
The cause is demonstrated by the adjacent road cutting sluiced out over a series of heavy rainfall events in the past four decades.

This is the site from which most of the sand that now fills Yidney Lake was washed over the past four decades

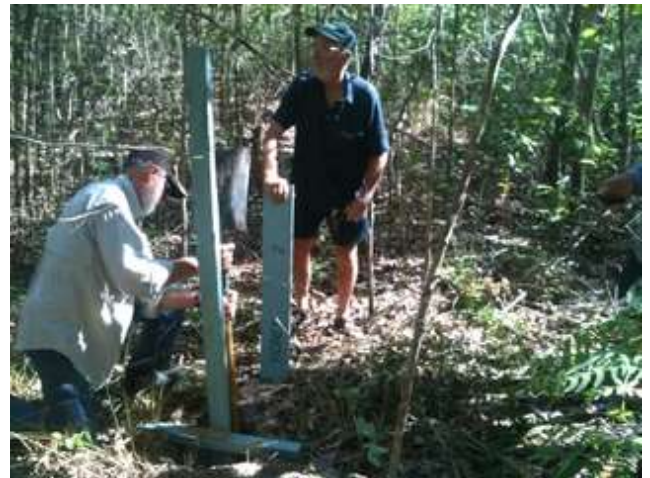
Location Description: This site was approachable from the Yidney Scrub end of the lake where there is evidence of some sediment moving down the gully to the lake. It is not though the main source of sediment which appears to come from the north eastern end of the lake. The site wasn't too far from the edge of the water due to a succession of heavy rainfall years,

Installed: 30th November, 2012. When the datum pole was installed the lake was at a high level and water was within 30 cms of the ground surface. It is close to and on the western side of a large *Eucalyptus teriticonis*.
